## **Geological Solutions for Providing a Scientific Basis for Differing Site Condition Claims**

### **Abstract**

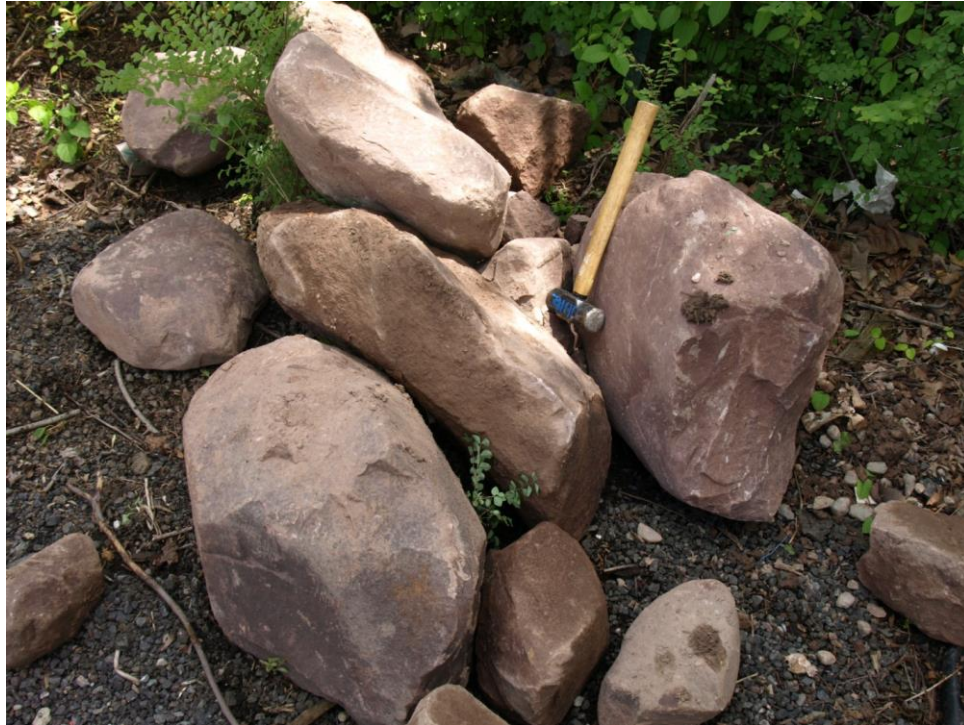
Based on the presence of mineralized joints, sub-angular/tabular shape aspect, and curved scratches, our conclusion was that the boulders were locally harvested (not of glacial origin), introduced from the shaft walls during drilling of fractured ground and dragged about during the drilling or mucking process before they were removed from the base of the shaft. Boulder composition was an identical match with the local Passaic bedrock. They were not Paleozoic quartzite or limestone which had been reported as indigenous boulders from within the Passaic

Formation by other field workers. Indeed, these observations forced the conclusion that the boulders were introduced from the shaft walls during construction drilling.

**Figure 3** – View of subangular boulders and cobbles of Passaic Formation siltstone and sandstone mucked from base of Shaft #23. Note the tabular aspect of the boulders, a relic of original bedding, and the incipient polishing by mechanical means. Hammer is 38 cm (15”) in length. (Dukelabs digital image taken 14 June 2013.)

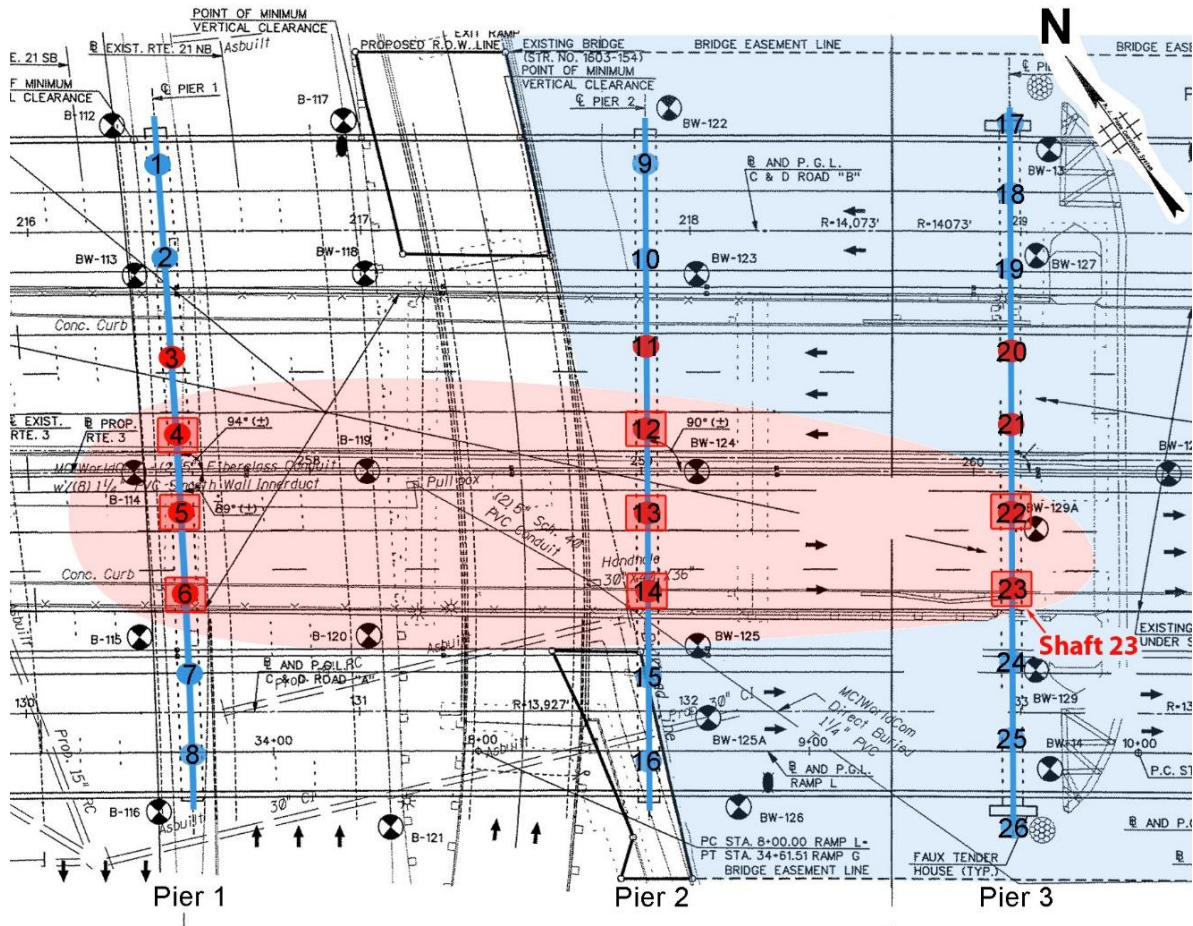
**Figure 4** – Site map showing the eight problem shafts (4, 5, 6, 12, 13, 14, 22 and 23 – boxed and numbered red circles) drilled in Piers 1, 2 and 3 and how they define a NW- to SE-trending zone of similar ground effects (pink ellipse) both on land (uncolored) and within the river (blue).

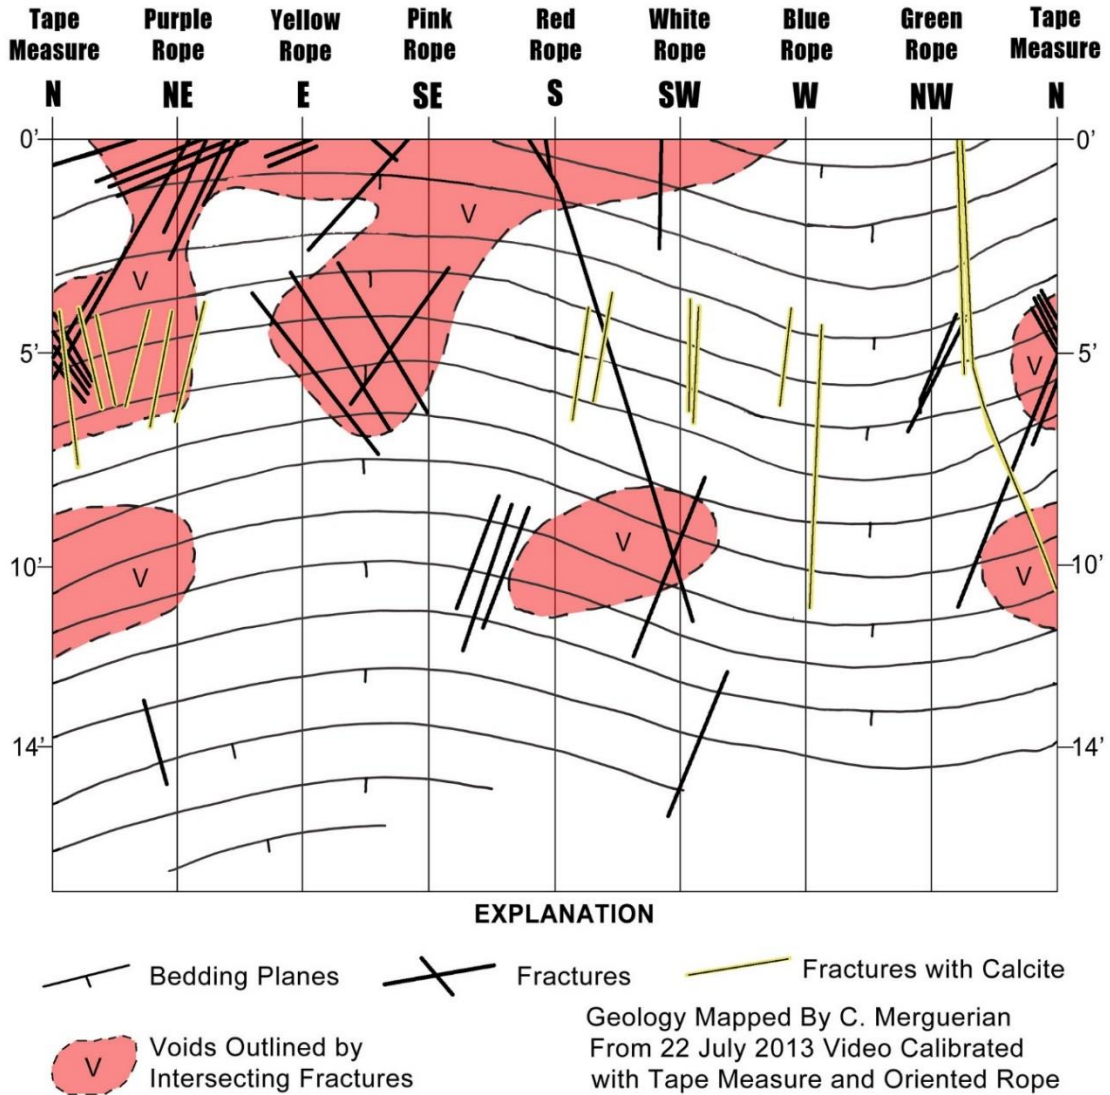
## CIRCUMFERENTIAL MAP - SHAFT 23 ROCK SOCKET PASSAIC RIVER BRIDGE

**Figure 6** – Circumferential geological map of bridge Shaft #23 rock socket of 90” (7.5’) diameter showing orientation of inclined bedding planes (thin black lines with tick marks), intersecting steep to gentle fractures (thick black lines) and open voids where blocks fell out of socket sidewall (v - pink areas). Also shown are mineralized fractures in yellow and black. Drawn with no vertical exaggeration. Compass directions are magnetic.

Figure 6 shows that four major open voids exist in the drilled rock socket of Shaft #23 from the base of the casing to about 8' depth, then again at about 10' depth. The voids are 3' to 8' in extent, extend a few feet deep into the sidewall and are concentrated up-dip in the eastern half-perimeter of the rock socket as would be expected if the blocks initially slid along bedding planes into the rock socket. Many of the open voids were found to terminate against steep planar fracture surfaces suggesting emphatic fault control of blocks that fell into the shaft along the regional dip of bedding planes. Figures 6 and 7 clearly document the relationship between areas of multiply fractured bedrock and associated angular voids detected in the subaqueous videos.

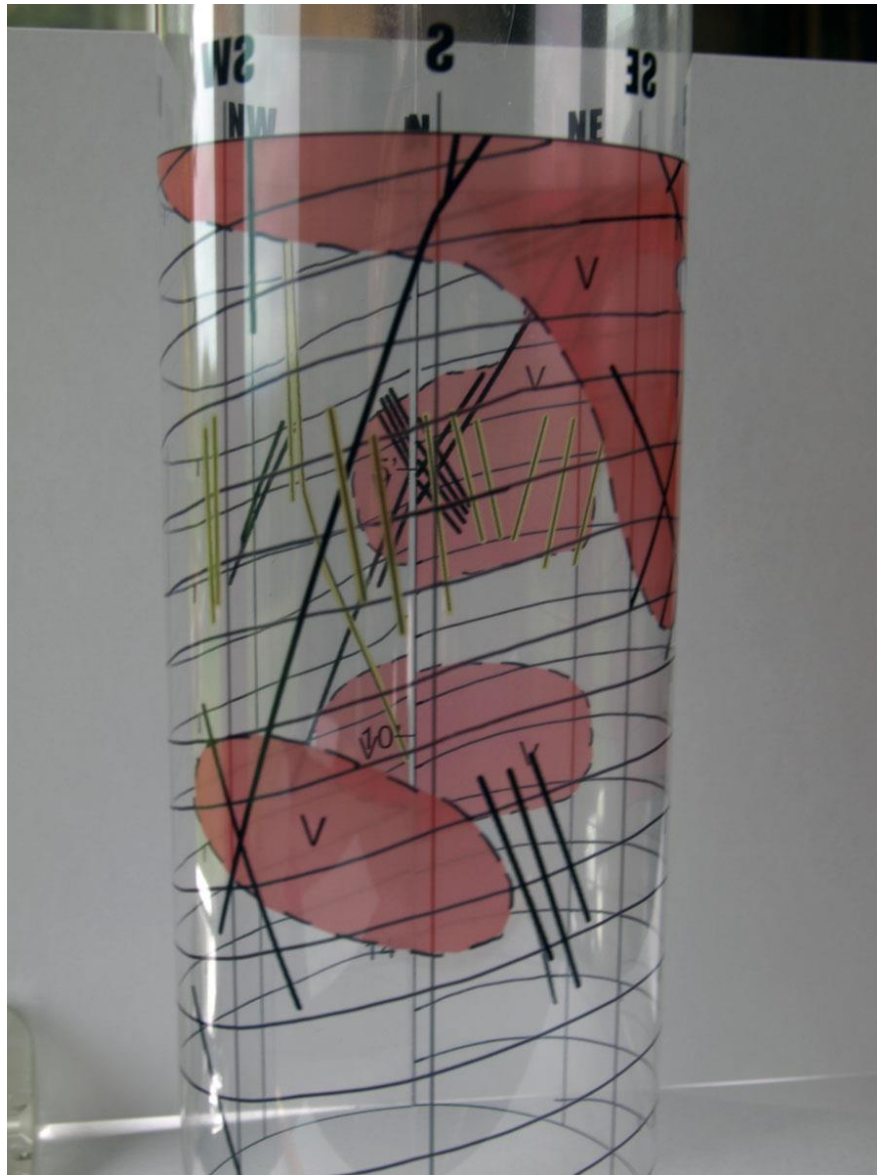
**Figure 7** – Northward view of Shaft #23 rock socket acetate map of Figure 6 curled into a cylinder showing the relationship of bedding planes ( $\sim 14^\circ$  NW dip [thin closely spaced lines]), NNE-, NE- and NW-trending fractures (steep, black lines), and voids (pinkish areas - v). Note that some of the steeper, NNE-trending fractures (outlined in yellow) are mineralized by calcite or whitish zeolite, common minerals found within faults and joints in the Newarkian strata and also observed in the boulders shown in Figure 3, above. Not obvious are gently inclined ( $\sim 14^\circ$ ) fractures that parallel bedding near the top of the map at the base of casing.

The steep dislocations fall into three major geometric classes. The most prominent and through-going mapped feature is a fissure that extends through the rock socket center and downward over 10' in extent with a  $N35^\circ E$  strike and  $75^\circ NW$  dip (center of image in Figure 7). Also mapped were at least five (5) less extensive fractures that parallel this main fissure as is common in fault zones. There is also a younger set of shorter, closely spaced mineralized conjugate fractures with a  $N25^\circ E$  strike and  $80^\circ SE$  dip fanning through vertical to dips of  $80^\circ NW$ . These discontinuities overlap and seem to crosscut the major NE-trending fracture set.

The steeper conjugate fractures sometimes show mineralization with calcite or a whitish zeolite mineral as indicated by yellow and black markings in Figures 6 and 7. A third prominent set of steep fractures strike N40°W and dip 70° toward the NE. A fourth set of dislocations occur near the top of rock. These are closely spaced, shallow in dip and cut bedding at a very low angle. These are simple bedding plane joints that trend NE and dip very gently (~14°) NW.

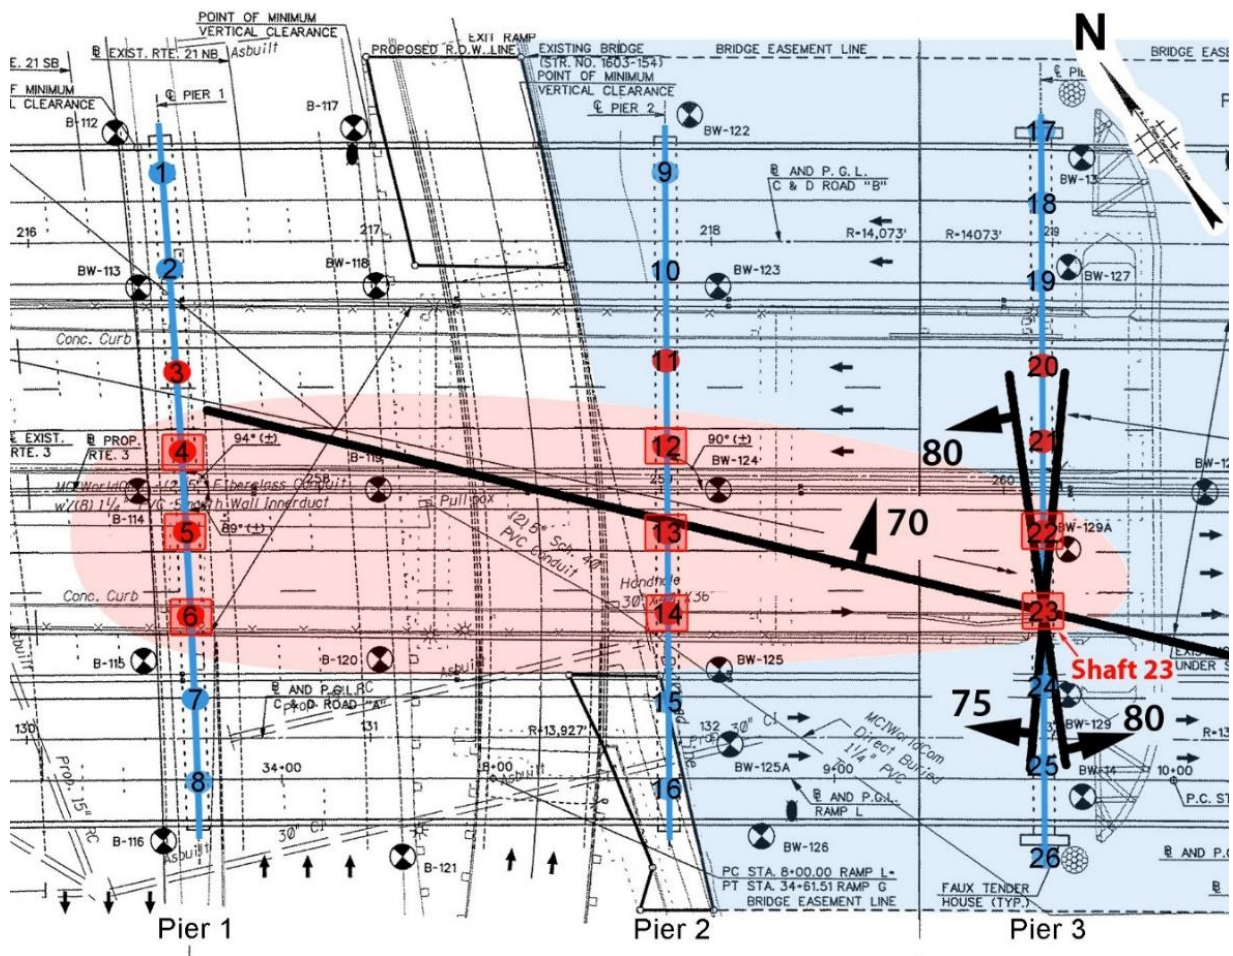
Note that on Figures 4 and 8 that the eight DSC caissons (Shafts #4, 5, 6, 12, 13, 14, 22 and 23) are not evenly distributed throughout the jobsite but are spatially oriented with a NW to SE alignment parallel to the NW-SE faults. This is additional evidence for a DSC with 17.8% of the 45 shafts affected as the extension of mapped faults conforms to the pink ellipse of affected shafts shown in Figure 8. Thus, there appears to be geological continuity of cause and effect.

**Figure 8** – Plan view of DSC claim area (pink ellipse) that includes the eight problem shafts encountered during Piers 1, 2 and 3 drilling of the bridge. The faults and related joints mapped from Shaft #23 are plotted to show their crosscutting relationships and geometric structural control on the associated problem shafts of the DSC claim. Note that the three steep fracture systems shown in Figures 6 and 7 (N40°W strike, 70°NE dip; N35°E strike, 75°NW dip and N25°E strike with conjugate dips fanning from 80°NW through vertical to 80°SW). These intersecting fractures extend outward from that zone of convergent intersection and cut gently inclined in-situ bedding planes and sub-parallel shallow joints at Shaft #23. Note that all faults were plotted with respect to True North as the magnetic declination at the site in 2013 was -12° 50' (12° 50'W of True North).

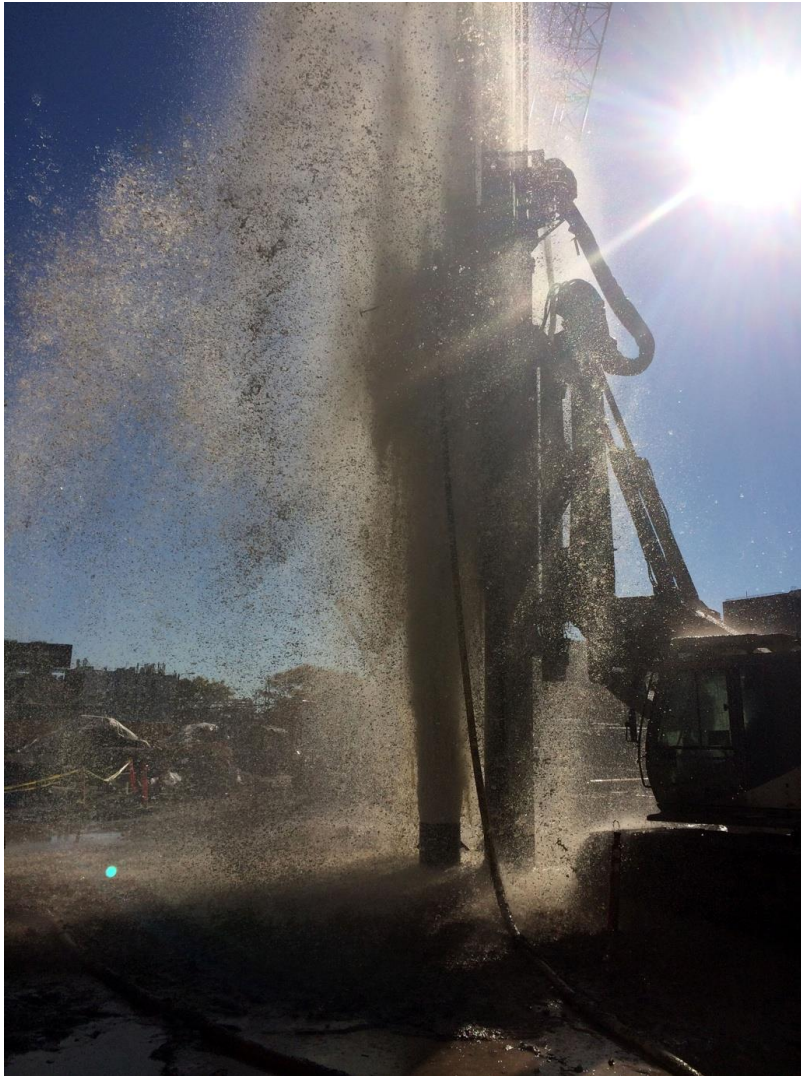
**Figure 9** – View of as-built anomalous water + material flow and geysering associated with caisson drilling in November 2015 at a terrestrial caisson/pile drilling job site. (Contractor image.)

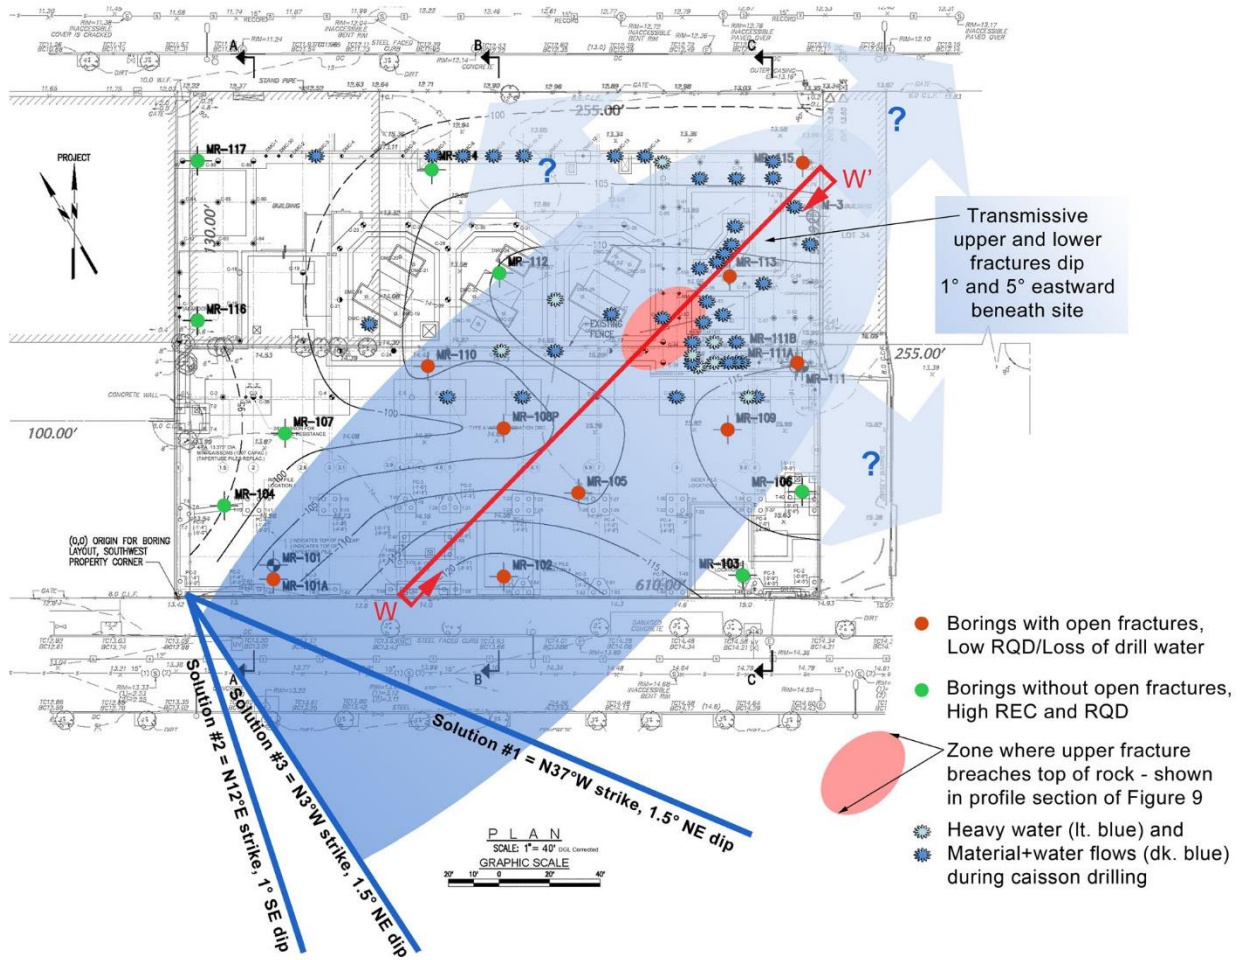
Two very gently inclined fracture zones descend below the top of rock at the job site based on the four fault plane solutions presented above. Figure 15 shows a conservative visualization of the east-dipping subsurface fracture system footprint (truncated blue ellipsoid) and shows a rather remarkable spatial coincidence with borings whose logs reported water loss during drilling and logs showing fractures below more competent rock. The extended blue arrows with blue question marks are a reminder that the fractures certainly extend for some distance along their strike and dip and may extend well beyond the zones shown in blue.

**Figure 15** – Simplified plan map showing the three strike solution results of the three-point analyses presented in Figure 13 and 14 (dark blue lines) and two additional solutions not shown and borings harboring open fractures, low REC/RQD % and reported loss of drill water (red dots). Note the spatial coincidence of these borings with the projected footprint of the transmissive upper and lower fracture zones (eastward dipping blue ellipsoid) and their possible extensions down-dip and along strike (extended blue arrows). Also projected upward into plan view is the breached zone shown below in Figure 16 where the upper fracture zone is at or near the top of rock (pink ellipse).

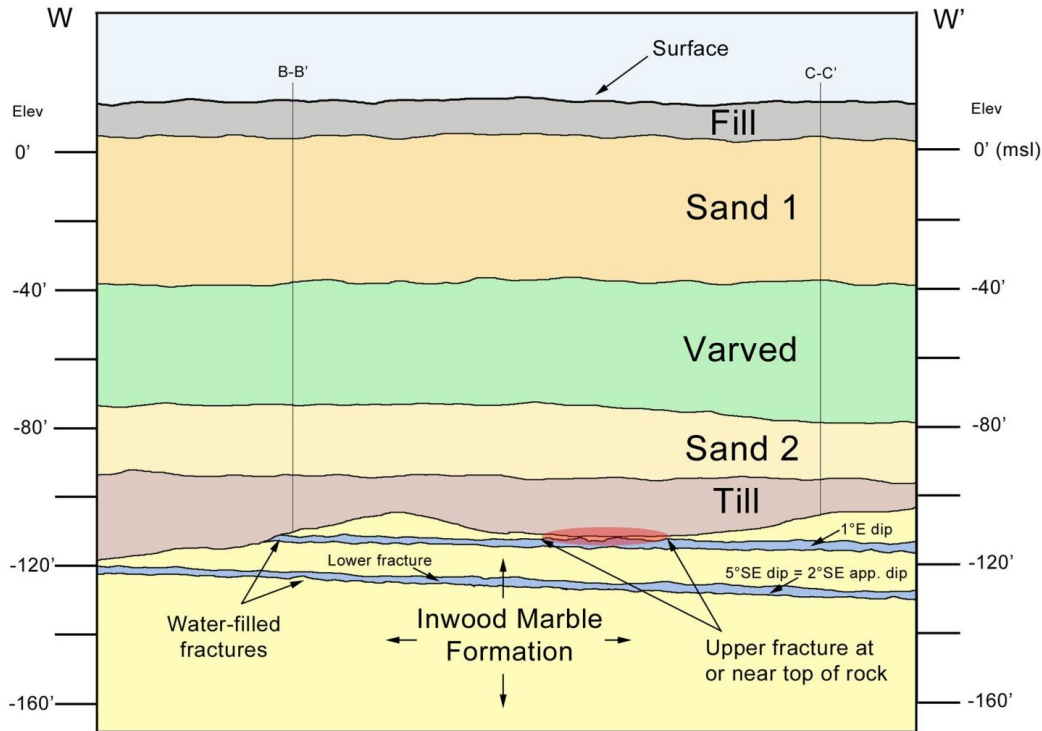
The profile section of Figure 16 shows that the upper fracture zone intercepts the buried top of rock near borings MR-101A and MR-102. It intercepts and connects directly with the till unit of the regolith. Here, at the western corner of the site where top of rock slopes down, the lower fracture will also intercept the top of rock, but off-site.

Thus, **both fracture zones** intercept the top of rock and connect to water-saturated regolith toward the west and as such provides a conduit for significant lateral flow of groundwater and sediment within the bedrock. Based on the data near MR-111B and MR-113, the upper fracture zone is at or near the fractured top of rock as shown diagrammatically by the pink elliptical zone in both map and profile section. (Compare Figures 15 and 16.) This hydrologic connection, even without any steep fractures, creates a unique plumbing system

**Figure 16** – Roughly west to east profile section (W-W’) keyed to Figure 15 showing overburden strata and Inwood Marble bedrock containing water-filled fracture zones (blue) detected beneath site using three-point problem solutions. Section is drawn roughly perpendicular to N-S strike of bedrock fractures. Water-filled transmissive bedrock fractures from three-point solutions are based on my interpretation of data from boring logs and by using the top of rock contour map and geological sections provided by the pre-bid geotechnical report for control. Note the unique bedrock to overburden plumbing system provided by the open-aperture subsurface fracture zones that intercept the top of rock in a few places. (Drafted without vertical exaggeration.)

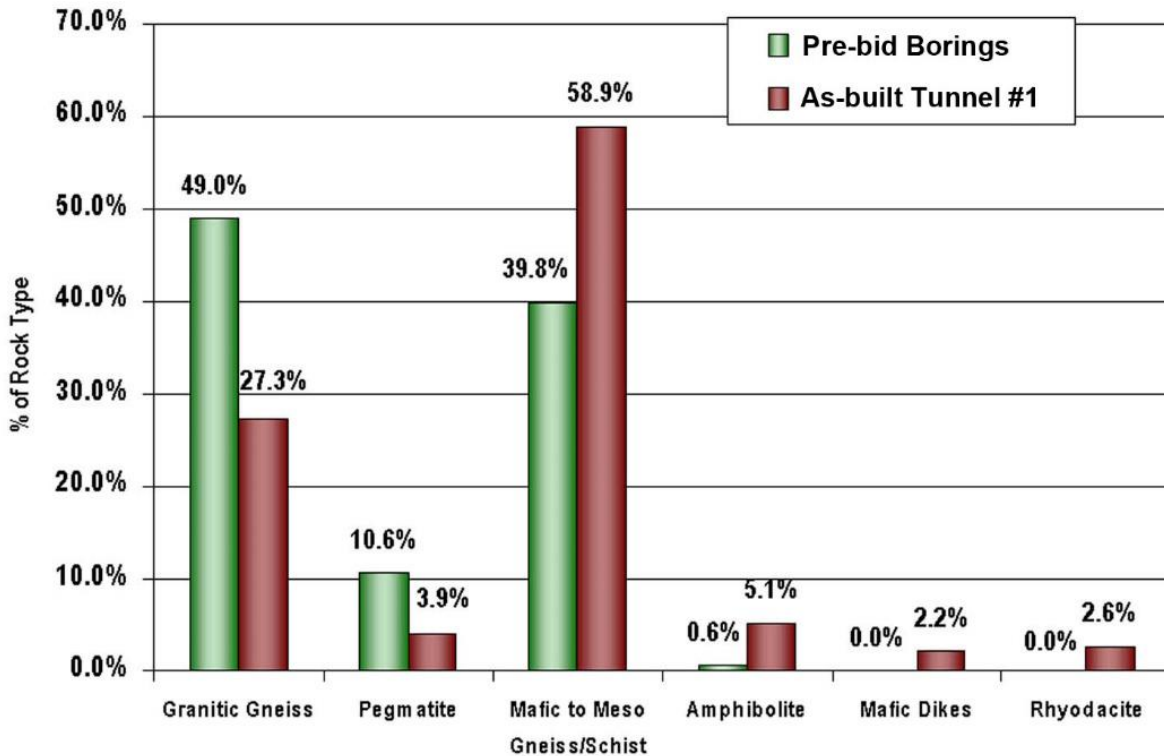
professional degrees in geology or geological engineering should not be relied upon without careful rechecking. In particular, anomalous lithologies are the common cause of changed condition losses in underground work. Professional geologists are more likely to accurately identify anomalous lithologies – many examples of misidentified rock types have resulted in lost time and delays related to differing site conditions. After careful mapping of the tunnel a comparison between lithotypes depicted in the borings at the tunnel horizon were clearly misleading in identifying the proportion of various lithologies in Tunnel #1 which in this case resulted in an improper choice of TBM for the tunnel drive (Figure 24).

**Figure 24** - Comparative bar graph showing the disparity between lithotypes identified by examining pre-bid borings (green) vs. those found to occur in a tunnel horizon by as-built mapping (red). Note the difference in the relative proportion of granitic and pegmatitic (felsic) rocks vs. the mafic, amphibolitic, and mesocratic (mafic and intermediate) rocks and the presence of unanticipated rocks of rhyodacite affinity. This compositional variation from pre-bid anticipation proved an impediment to efficient mining. (Adapted from Merguerian and Ozdemir, 2003.)

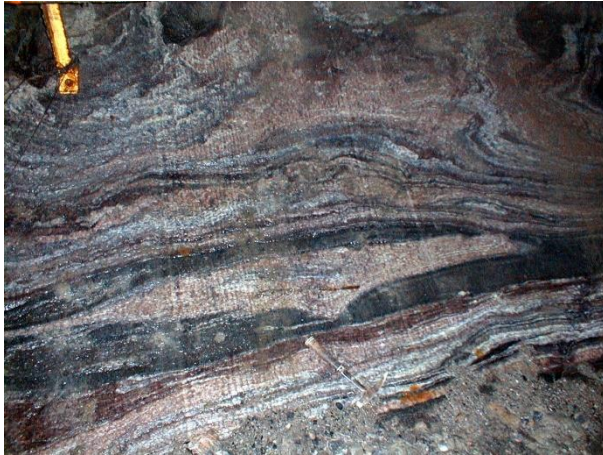
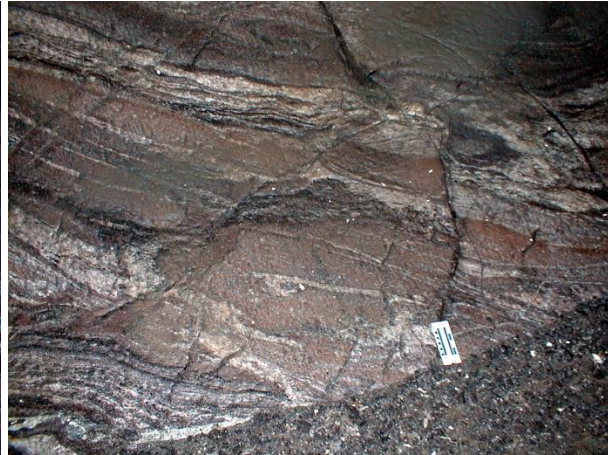
**Figures 27A, B** – Views of two of the 32 garnet zones mapped in Tunnel #1 showing the anomalously high concentration (up to 50%) of dense garnet that defines such zones. Highlighted in yellow on Table 1 (below) the garnet zones 9 (A.) and 21 (B.) were produced during phases of granulite- followed by upper-amphibolite facies metamorphism as detected in the petrographic analysis of mineralogy and rock mass textures.
