## **Geological Solutions for Providing a Scientific Basis for Differing Site Condition Claims**

### **Abstract**

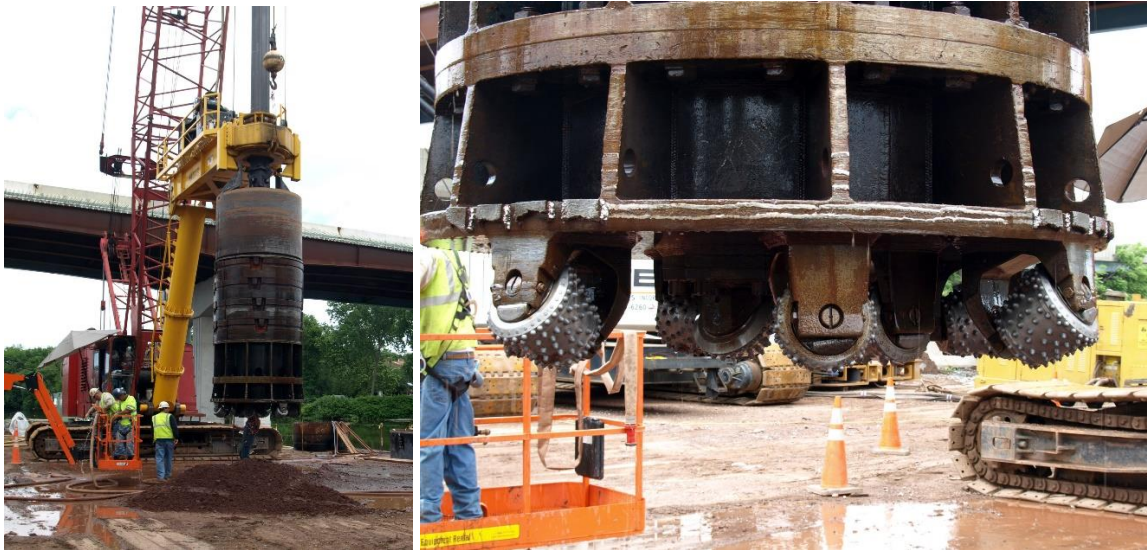
During construction of the bridge, 45 shafts of 96” diameter were drilled for bridge piers using identical means and methods and finished with 90” rock sockets. Difficulties in construction were encountered in drilling eight of the river shafts. In these instances, shaft construction was hindered by voids, high-water inflows and in-falling blocks of red-colored siltstone and sandstone. The ground conditions required remediation including grouting, additional drilling, reseating of casings and deepening of shafts. A view of the equipment used for subaqueous drilling is shown below (Figure 2).

**Figure 2** – Westward view of Shaft #23 construction rig near Pier 3 of job site in New Jersey (L) and close-up view of the cutterhead and cutters (R) designed for sedimentary rocks. (Dukelabs digital images taken 14 June 2013.)

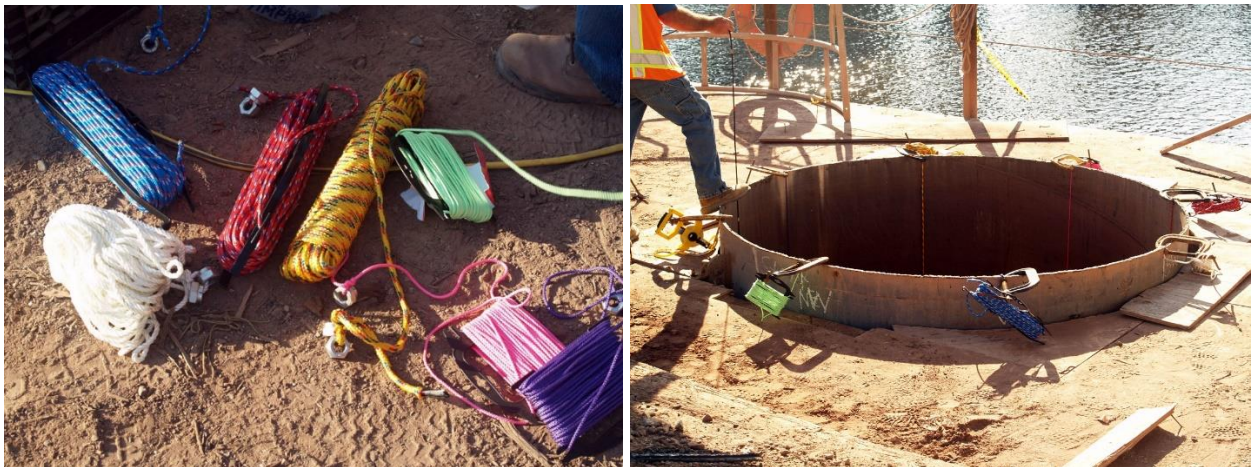
In order to calibrate and map the shaft interior we marked the walls by suspending weighted colored ropes with magnetic N, E, S, and W and intervening magnetic compass directions NE, SE, SW, NW so that calibration, recording and calculating the orientation of geological features could be accomplished (Figure 5).

**Figure 5** – Various ropes used with weights and C-clamps to hold ropes taught and vertical down the sides of the shaft in order to video each compass rose direction with depth calibration. Analysis of the color-coded videos allowed us to generate an accurate flat 2-D map of the interior of the rock socket.

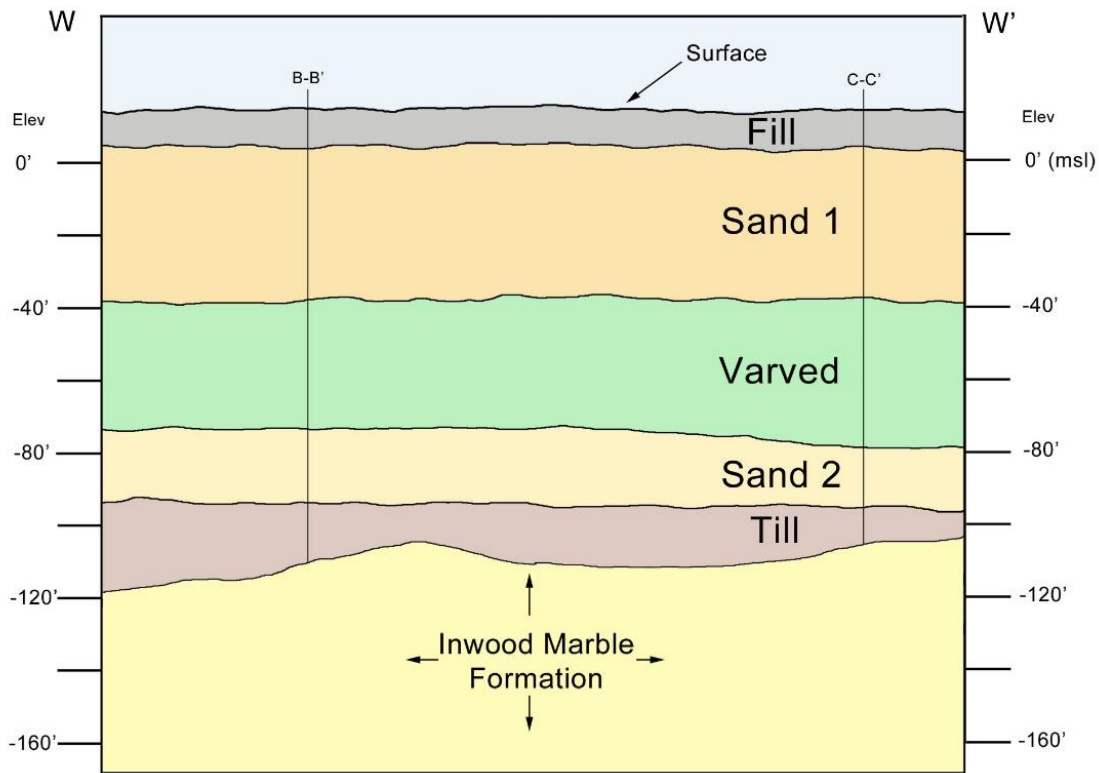
The stratigraphy of roughly 100' of overburden from the top down included Holocene fill, Pleistocene sand units, intervening varved strata and basal till below which penetrations into the Inwood Marble bedrock were met with persistent excessive water and material inflows (Figure 10).

**Figure 10** – Across site roughly W-E geological profile section drawn from data supplied in the geotechnical report showing overburden strata and the buried Inwood Marble bedrock layer. This view of the site was the anticipation and design criteria for the contractor’s approved means and methods.

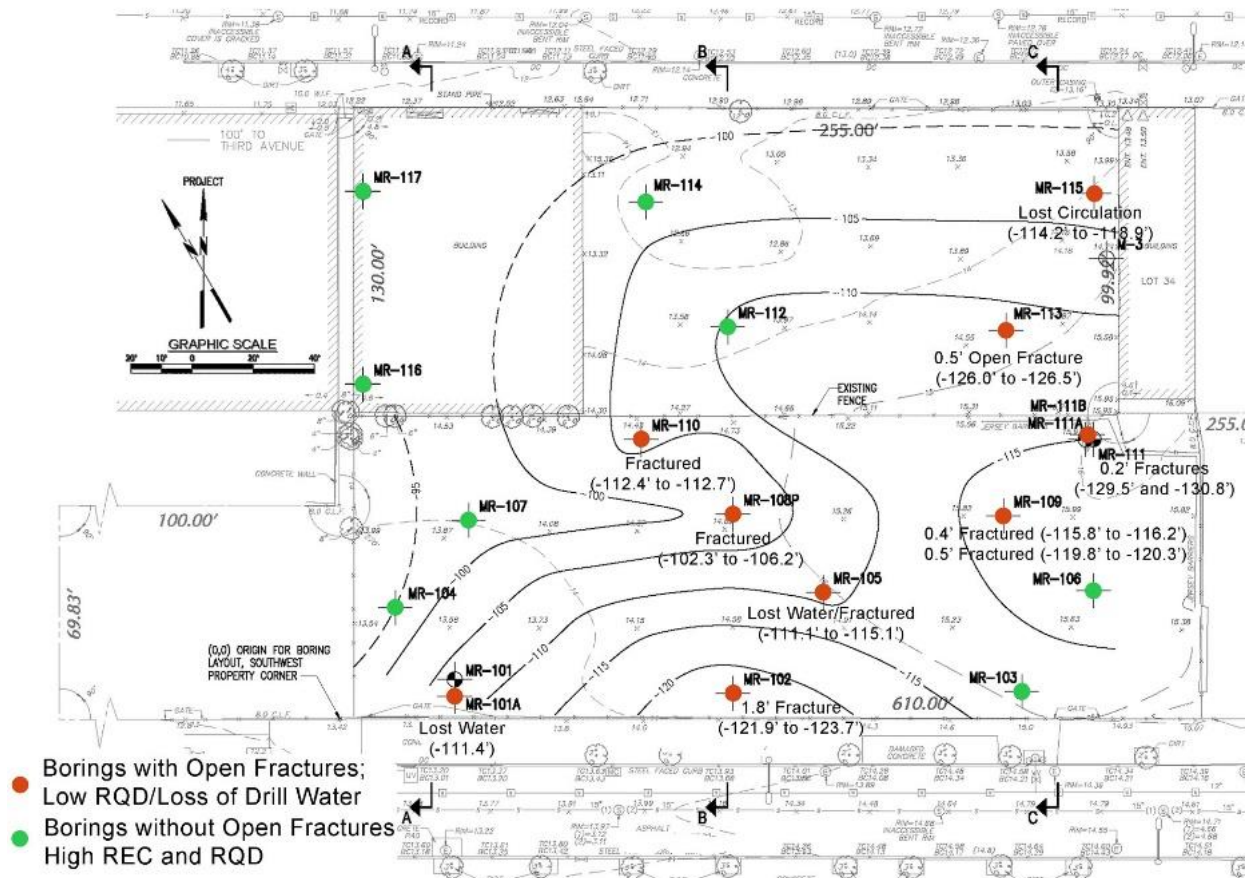
In order to better understand the pre-bid anticipation vs. the as-built contractor experience, we performed a careful study of the geotechnical information provided by two geotechnical reports and 17 associated boring logs. Figure 12 shows the positions of the 17 pre-bid borings performed in 2007 and 2013 and whose logs were included with the geotechnical reports. These data were used by contractors to evaluate the subsurface conditions and formulate baseline parameters for their winning bid and the means and methods for the construction project. Little data on foliation or compositional layering was to be found in the boring logs but the orientation of foliation joints show gentle dips ( $0^{\circ}$  to  $30^{\circ}$ ) for many of these primary features.

**Figure 12** – Site plan map showing topographic data, annotated boring locations (MR-series) and top of rock contours within the footprint of the site. Nine borings with open fractures, low recovery and RQD values, and/or reported "loss of drill water" are shown in red. Eight competent borings without reported open fractures and with high recovery and RQD values are shown in green. Note the E-W clustered trend of the red borings.

Examining the soil and core samples in February 2017 confirmed that no contractor could have anticipated the true ground conditions. Visual inspection showed that the core was competent and tended to be massive with some jointing. Thus, a pre-bid core analysis by any contractor bidding for work and guided by the supplied information on REC and RQD % would create an anticipation of hard- to medium-hard, blocky to closely jointed marble but would

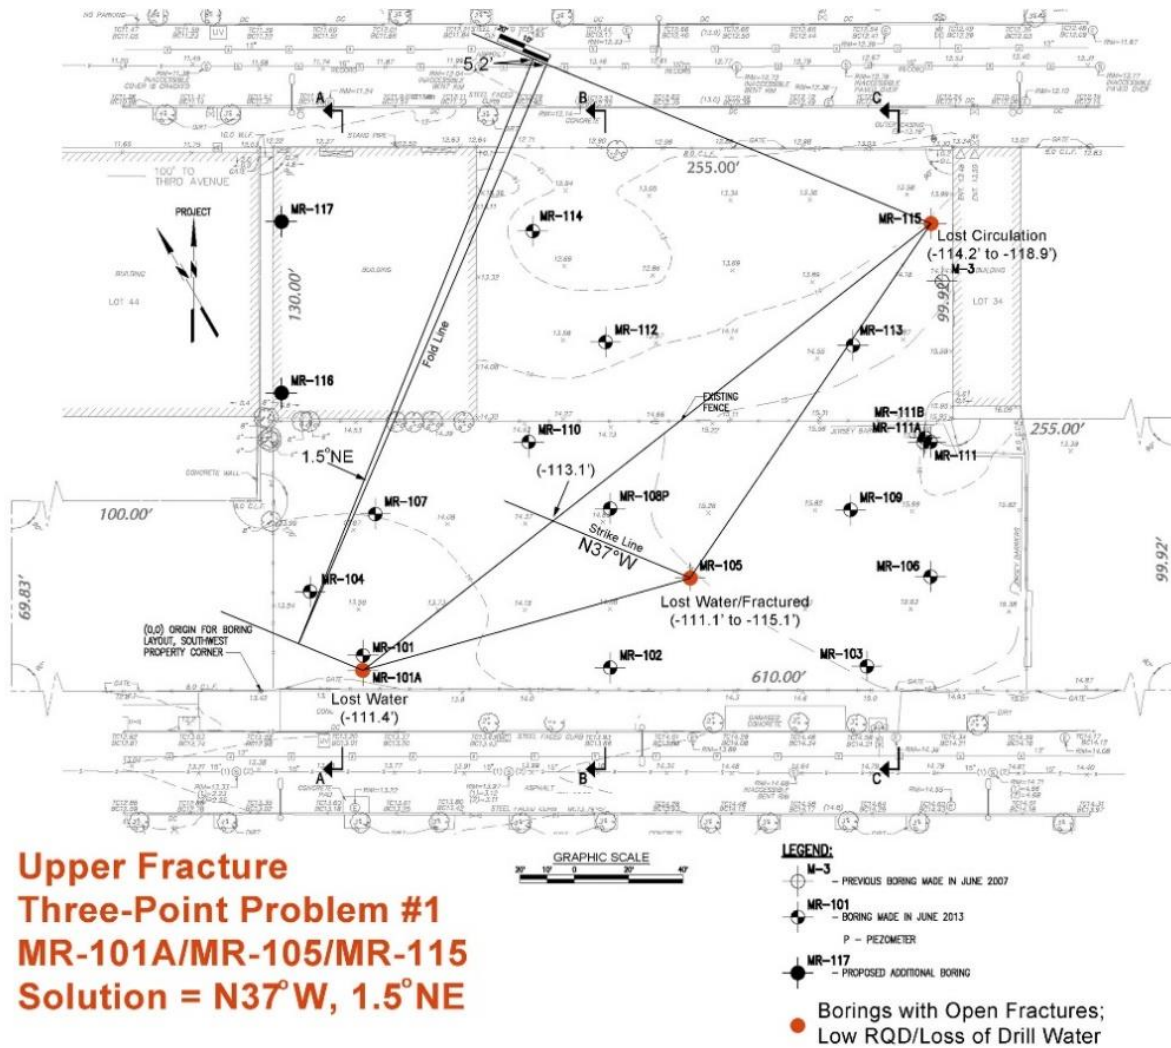
The clue that drew our attention came in the form of three widely separated borings that reported "*loss of drill water*" (MR-101A, MR-105, and MR-115). Loss of drill water and/or drop in the drill stem below top of rock is usually an indication of open voids or fractures. MR-101A lost drill water at -111.4' elev., MR-105 lost drill water between -111.1' and 115.1' elev. (a 4.0' interval), and MR-115 lost drill water between -114.2' and -118.9' elev. (a 4.7' interval). Since no casing is used in driving NX-core, drill water can escape the borehole at the initial pierce point of a void or fracture despite the report of lost drill water over a 4.0' (MR-105) to 4.7' (MR-115) interval. As such, these values can be considered maximum width values for these features. Alternatively, the void or fracture may encompass the entire interval. In order to perform the three-point analysis we employed an average "*loss of drill water*" elevation value for MR-105 (-113.1' elev.) and MR-115 (-116.6' elev.).

Figure 13 – Three-point solution #1 for upper fracture using data from borings MR-101A, MR-105, and MR-115.

Using the method described above the three-point problem solution #1) shows that three "loss of drill water" borings provided a solution that identifies an open fracture or fracture zone oriented N37°W, 1.5°NE. In order to test for and verify the lateral extent of the feature detected in Figure 13 we also grouped boring MR-101A, MR-105, and MR-115 as similar because of an RQD drop in Run 3C (64%) after much higher values in Runs 1C, 2C and 4C (REC and RQD % values both ranged from 95%-100% in these runs) and the presence of open (0.3') fractures. This allowed for two additional three-point solutions using MR-101A, MR-105, and MR-110 [Solution #2 = N12°E, 1°SE] and MR-105, MR-110, and MR-115 [Solution #3 = N3°W, 1.5°NE] (not shown here) which not only overlapped with Figure 13 result but yielded nearly identical strike and dip solutions.

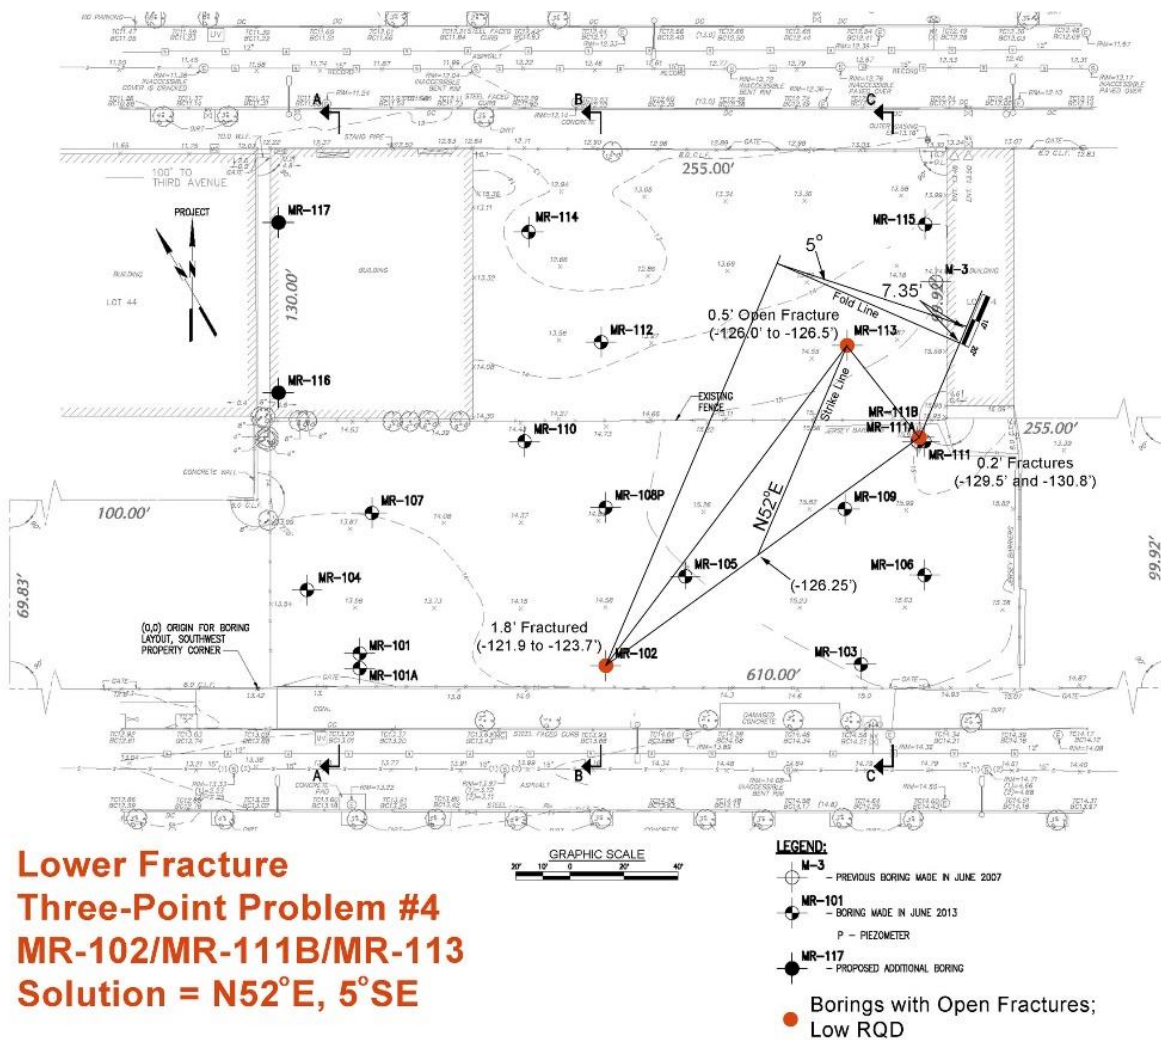
Borings MR-102, MR-111, and MR-113 show similar traits as those above in that they indicate a marked decrease of REC % and RQD % in lower core runs below a reach of competent rock. Using these data, three-point problem solution #4 shows a secondary deeper (lower) open fracture oriented N52°E and dipping 5°SE (Figure 14). The lower fracture is not as wide (0.2' to 1.8' wide) as the upper fracture and occurs 10' to 14' deeper than the upper fracture with slightly steeper dip.

Figure 14 – Three-point solution #4 for lower fracture using borings MR-102, MR-111B, and MR-113.

Thus, the three-point solutions identified two horizons of open aperture fractures that descend across and below the site and dipping gently eastward within the marble rock mass. Clearly, they are important players in the subsurface plumbing system that underlies the site.

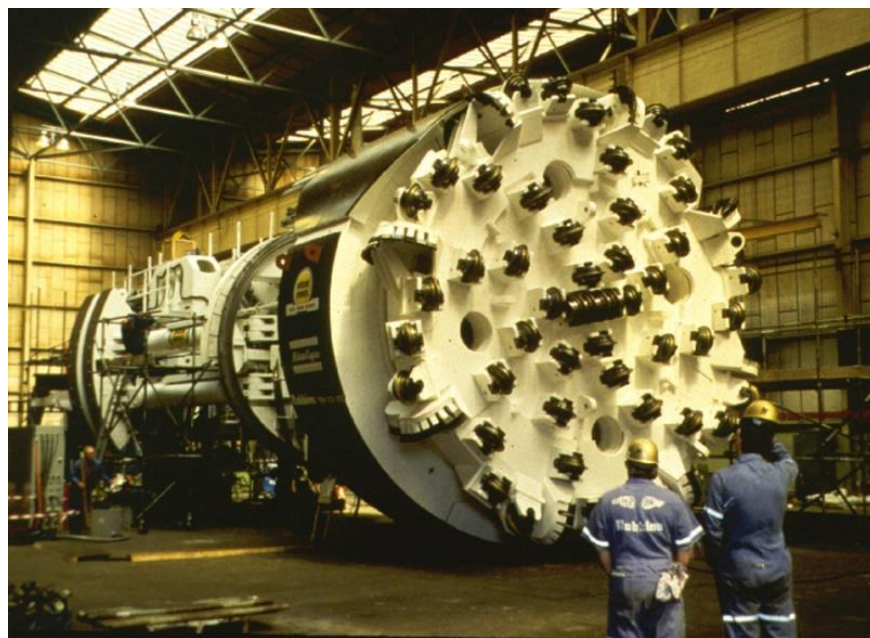
The main issues encountered on this job were much lower than anticipated TBM advance rates, side-wall and crown instability, invert heave, short-stand up times and resulting missed construction deadlines and lost production costs. The main culprits in this case were the Geotechnical Baseline Report (GBR), a contract document which identified the wrong NYC rock formation (Hartland Formation) with rock mass properties vastly different from that which was encountered and a pre-bid drilling program that was too widely spaced and under-analyzed. This consulting engagement required a number of parallel geological efforts rooted in detailed mapping of the entire tunnel, petrographic analysis of collected rock specimens, rock mass statistical analysis which included lithotypes, mineralogical and density studies, geochemical and geochronologic analysis, characterization of zones of geological anomalies and comparisons of decreased advance rates and utilization to geology and as-built TBM performance data (Merguerian and Ozdemir 2003).

**Figure 17** – View of front 84’ of the roughly 300’ long Robbins single-beam hard rock TBM (Model 235-282) which was assembled in bellout at base of main access shaft of Tunnel #1.

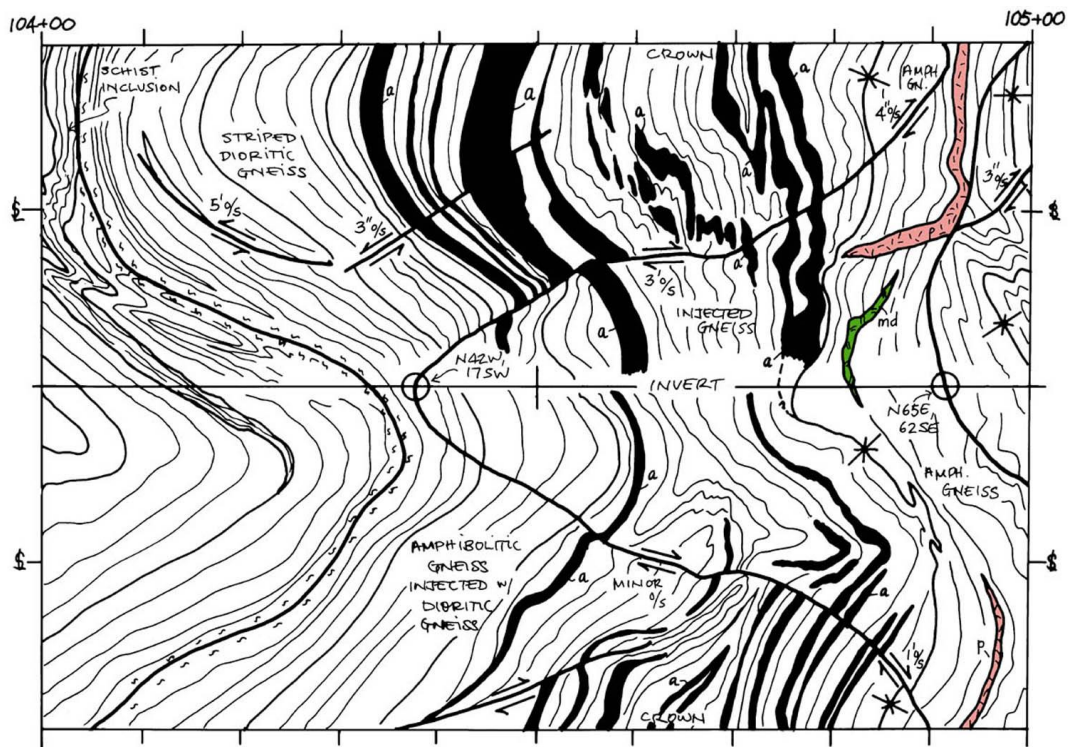
**Figure 19** – Geological map of Tunnel #1 shows granulite-facies amphibolite gneiss and younger dioritic orthogneiss cut by pegmatite (p) and a mafic dike (md). The amphibolitic gneiss is locally sheared but clearly occurs as inclusions in the dioritic gneiss. The tunnel invert is shown along the center of the map and the tunnel walls curl upward into a cylinder to join at the crown. The position of the tunnel springline is shown at the map edge. This map, one of 250 in the unpublished Tunnel #1 Map Portfolio, records 100' of the tunnel. A low-angle reverse fault oriented N42°W, 17°SW cuts the invert at Station 104+38 (tunnel invert bearing is N22°E). A younger N65°E, 62°NE brittle fault cuts the invert at Station 104+91. Original map scale 1" = 10'; tunnel diameter 23' 2".

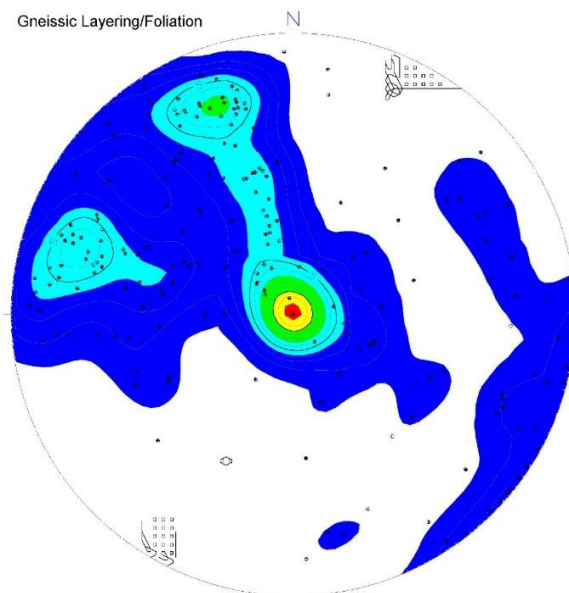
Internal rock fabrics (gneissic layering) and faults were remeasured using oriented rolled mylars of the individual maps utilizing a Brunton compass as shown in Figure 20. Such measurements disclosed that the gneissic fabric of Tunnel #1 was not in a favorable orientation for efficient TBM mining. Although the pre-bid data indicated a NE-trending steep-SE dipping rock foliations our stereonet analysis of the as-built gneissic layering between Stations 4+00 and 254+00 demonstrated that 26 of 235 poles (11%) indicated subhorizontal layering (Figure 21). Overall 64 poles (27%) showed gentle dips of less than 30°. Thus, subhorizontal to gently dipping rock fabrics underlie broad tracts (38%) of Tunnel #1. The structural grain of Tunnel #1 presented an unfavorable rock fabric orientation for productive TBM mining.

**Figure 21** – Subhorizontal clustering of stereonet poles (27%) together with anticipated NNE- and ENE-strike and steep SE dips of gneissic layering/foliation (n = 254).

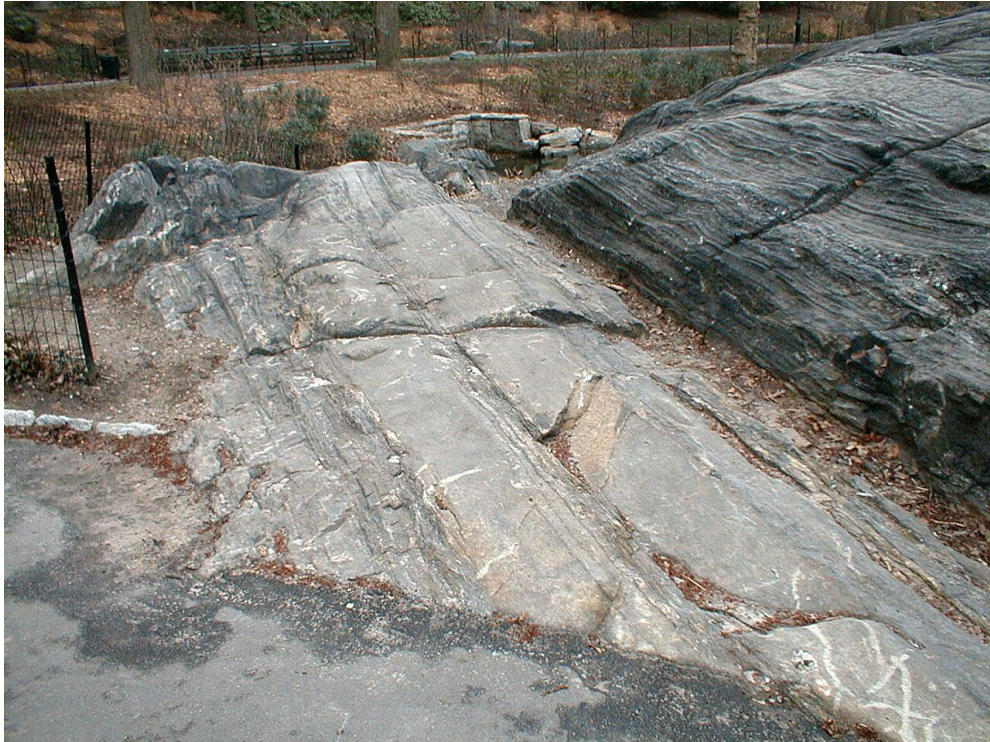
**Petrographic Analysis.** Petrography is one of the basic tools used extensively in geological analysis of crystalline rocks as it allows for identification of minerals, mineral crystal textures and metamorphic paragenesis. The process involves collection of rock samples or pieces of rock core and precise preparation of petrographic slides. The slides are 30-micron thick slices of rock sandwiched between two pieces of glass (base slide and a thinner cover slip) which together form a rock “windowpane” held together by epoxy of known optical index. In conjunction with geological mapping, metamorphic rocks reveal their structural and metamorphic history and in the case of Tunnel #1, proved that the rocks were not schist or granofels of the Hartland Formation (Figure 22).

**Figure 22** – View of typical interlayered Hartland schist and granofels from an exposure at the SE part of Central Park in New York City. (Digital image taken 04 April 2003.)

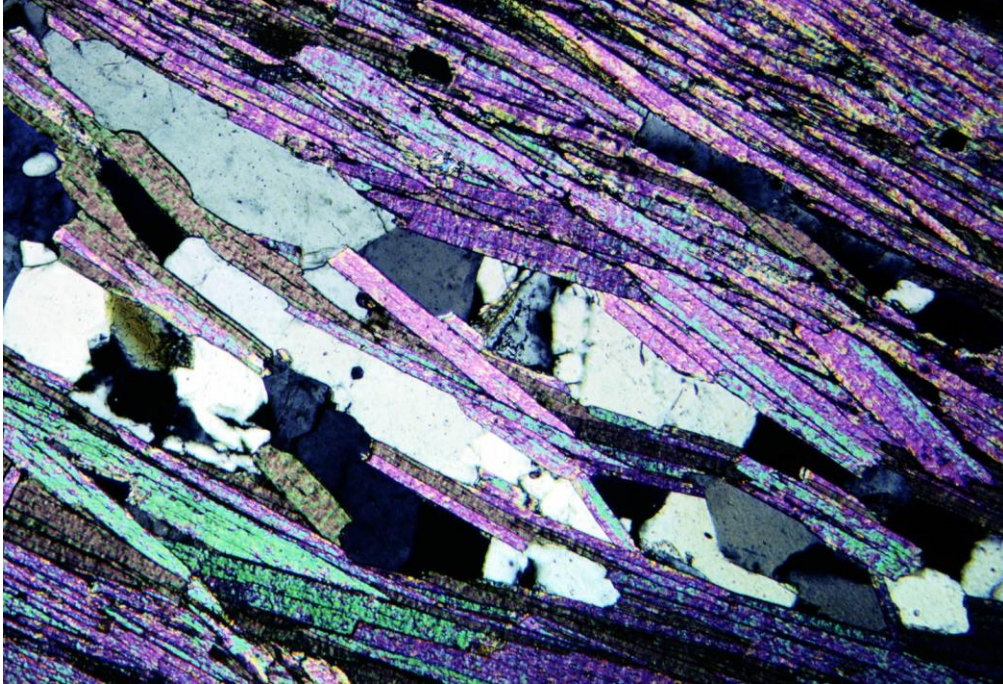
Compare the rock textures shown below between foliated rocks of the anticipated Hartland Formation (Figure 23A) and a leucocratic orthogneiss found in Tunnel #1 (Figure 23B). Proper petrographic analysis would have alerted bidders to this lithologic departure from pre-bid anticipation but sadly, little competent petrographic work was conducted pre-bid on this job.

**Figure 23A** – Photomicrograph in crossed nicols of aluminous Hartland schist (Sample N403-1; World Financial Center site, lower Manhattan). The section shows fine-textured lenticular quartz and minor plagioclase separated by aligned muscovite and minor biotite (highly colored crystals). Such directional mineral growth results in a penetrative micaceous foliation that splits readily because of the parallelism of relatively soft mica flakes.

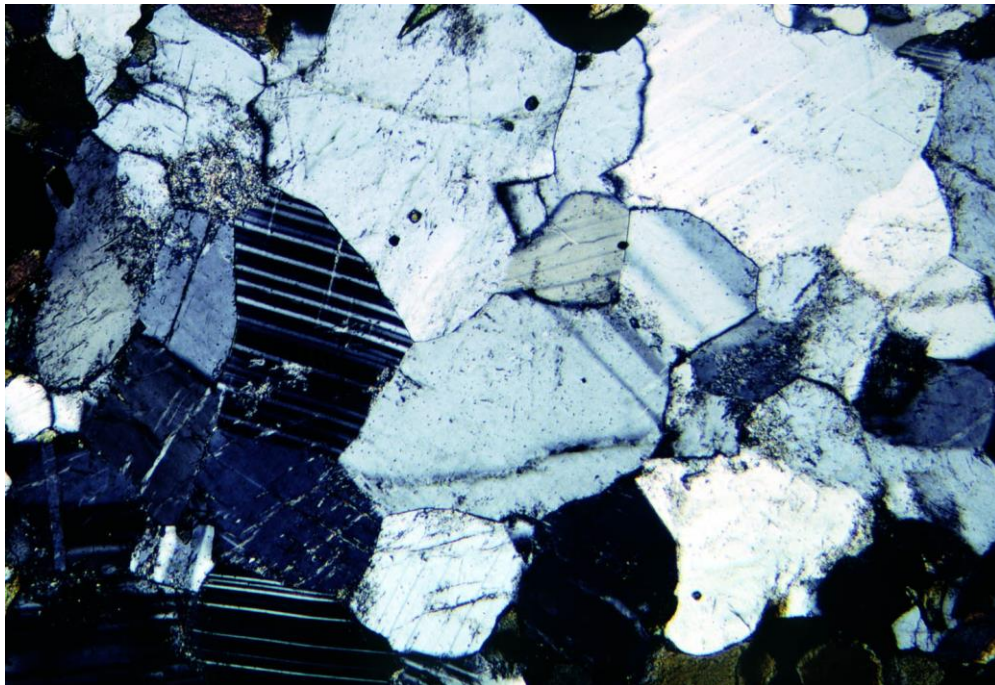
**Figure 23B** – Photomicrograph in crossed nicols of Tunnel #1 leucocratic orthogneiss (Sample Q085; Station 159+80) showing granoblastic intergrowth of plagioclase and minor quartz. Note the granular texture, the stable  $120^\circ$  grain boundaries of the interlocking plagioclase, and the lack of any penetrative foliation. Both photomicrographs of Figure 23 are 2 mm across.

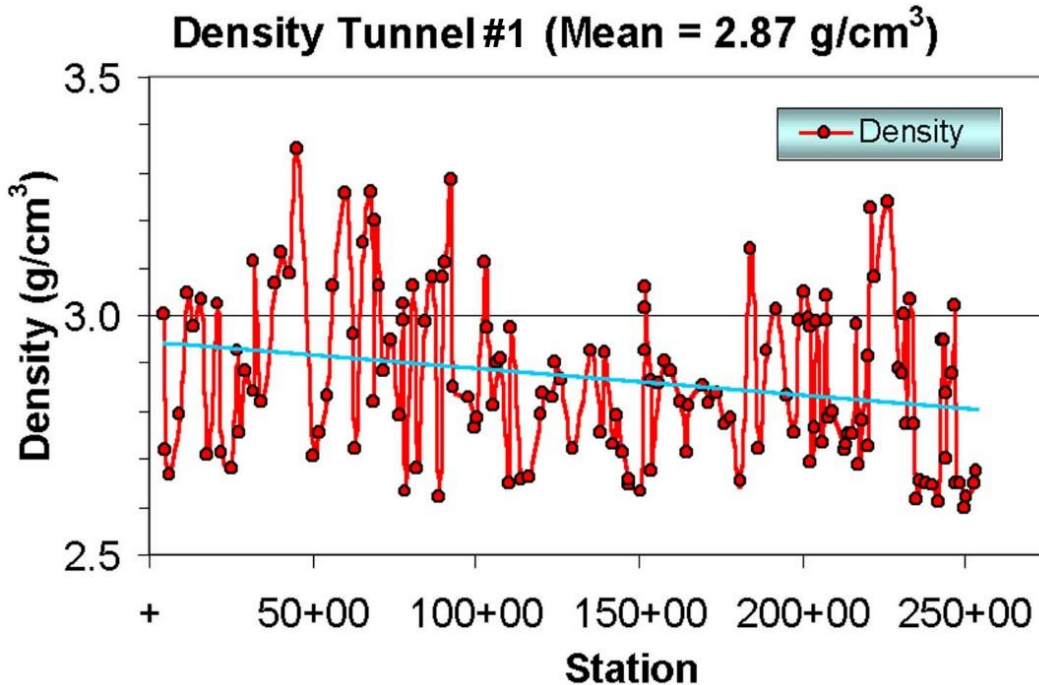
**Density Analysis.** Overlooked by many investigators, the density or specific gravity of rocks is a simple and useful litmus test for predicting TBM penetration. Higher density rocks are less penetrable simply because they tend to contain dense and/or hard minerals such as garnet, pyroxene, and aluminosilicate minerals such as sillimanite and kyanite. Density is readily measured using simple, inexpensive apparatus (Merguerian 2005a). A density profile along the tunnel alignment can help predict variation in density over a planned TBM expedition and can efficiently identify anomalous zones or trends in rock mass properties (Figure 25).

**Figure 25** – Rock mass density variation as compiled from sawn slabs from 161 samples collected during as-built mapping of Tunnel #1, NYC. The graph indicates that the bulk density of the tunnel varied from 2.62 to 3.35 gm/cm<sup>3</sup> and that density decreased slightly toward the higher stations (sloping blue line) as shown by the mapping. The mean density (2.87 g/cm<sup>3</sup>) was in keeping with the lithotype analysis (See Figure 24.) that indicated that more intermediate- to mafic lithologies were penetrated in the tunnel by comparison to what the pre-bid borings indicated. Typical schist and granofels which constitutes the Hartland Formation should have averaged about 2.55 g/cm<sup>3</sup>. (Adapted from Merguerian and Ozdemir 2003.)

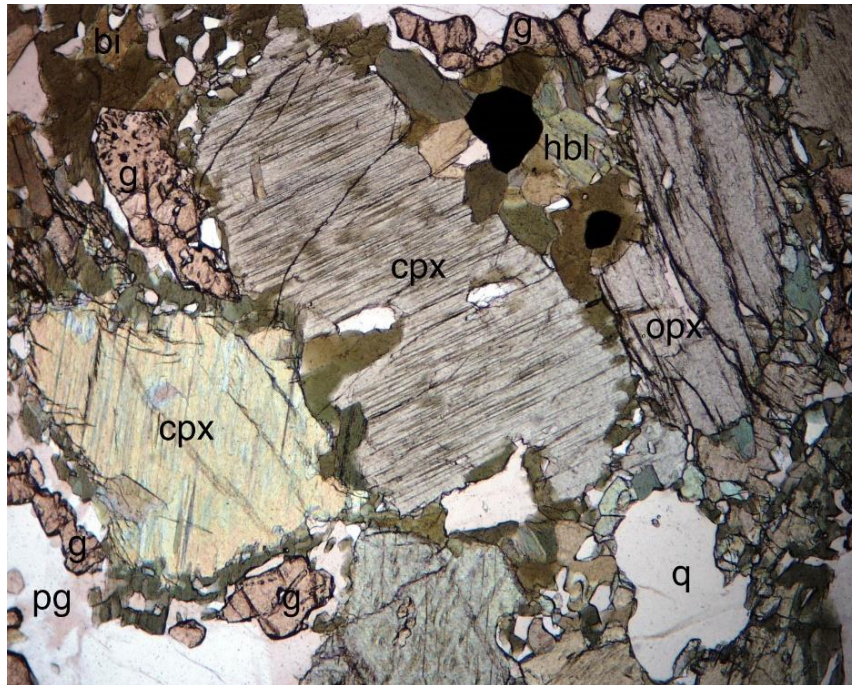
**Figure 26A** – Photomicrograph in plane-polarized light of Tunnel #1 mafic gneiss showing coarse-textured granulite facies texture in the form of partly recrystallized orthopyroxene (opx), clinopyroxene (cpx), and primary garnet (g). Quartz = q. Note the thin overgrowths of hornblende (hbl), granular garnet (g) and biotite (bi), the result of secondary metamorphic recrystallization. (Sample Q114; Station 15+90; 2 mm field of view.)

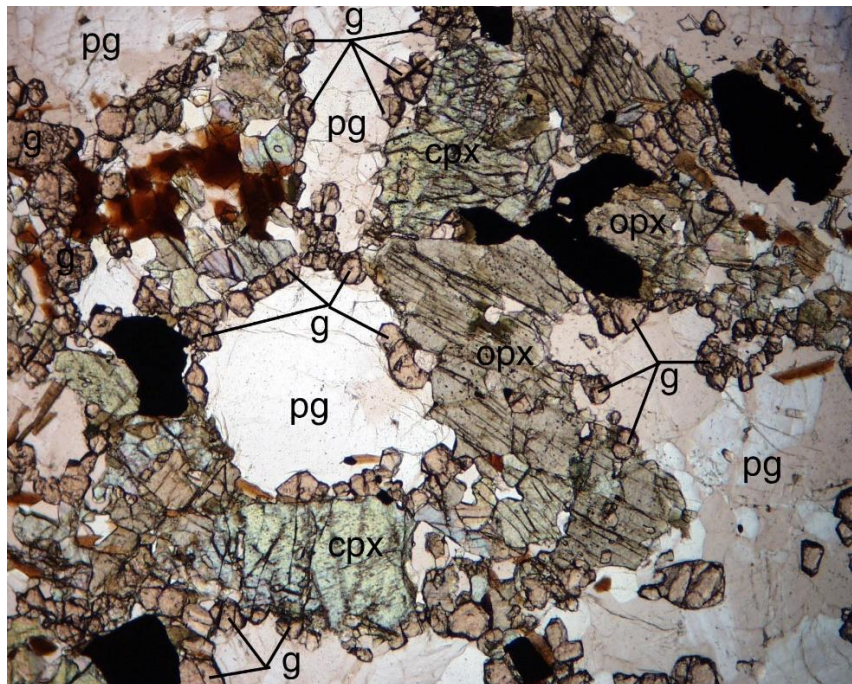
**Figure 26B** – Photomicrograph in plane-polarized light of mesocratic gneiss showing “garnet necklace” structure. Note the semi-circular patches of high relief garnet. This replacement texture results from the production of garnet and hornblende reactions rims adjacent to primary coarse-textured orthopyroxene, clinopyroxene, and plagioclase during secondary metamorphism. Same notation as above. (Sample Q146; Station 80+64; 2 mm field of view.)
