## A Study of the flooding from Hurricane Ida on Staten Island, NY

Alan I. Benimoff  
Department of Engineering and Environmental Science  
College of Staten Island  
Staten Island , NY 10314  
alan.benimoff@csi.cuny.edu

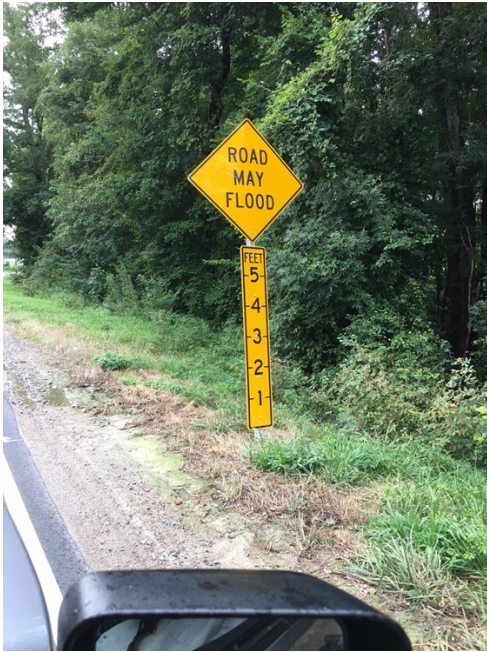
Figure 1: Suggested Signage for potentially flooded areas.(photo taken by Alan Benimoff on a road in the state of Virginia)

Furthermore, since we now know the locations of potentially flooded roadways, Staten Island residents could be alerted to the depth of future flooding by the installation of “road may flood” signage with at staff gauge (Figure 1).
